Name Of Dam: BENS BRANCH DAM
Location: WISE COUNTY, VIRGINIA
Inventory Number: VA. NO. 19509

PHASE I INSPECTION REPORT

NATIONAL DAM SAFETY PROGRAM

SCHNABEL ENGINEERING ASSOCIATES, P.C./
J. K. TIMMONS AND ASSOCIATES, INC.

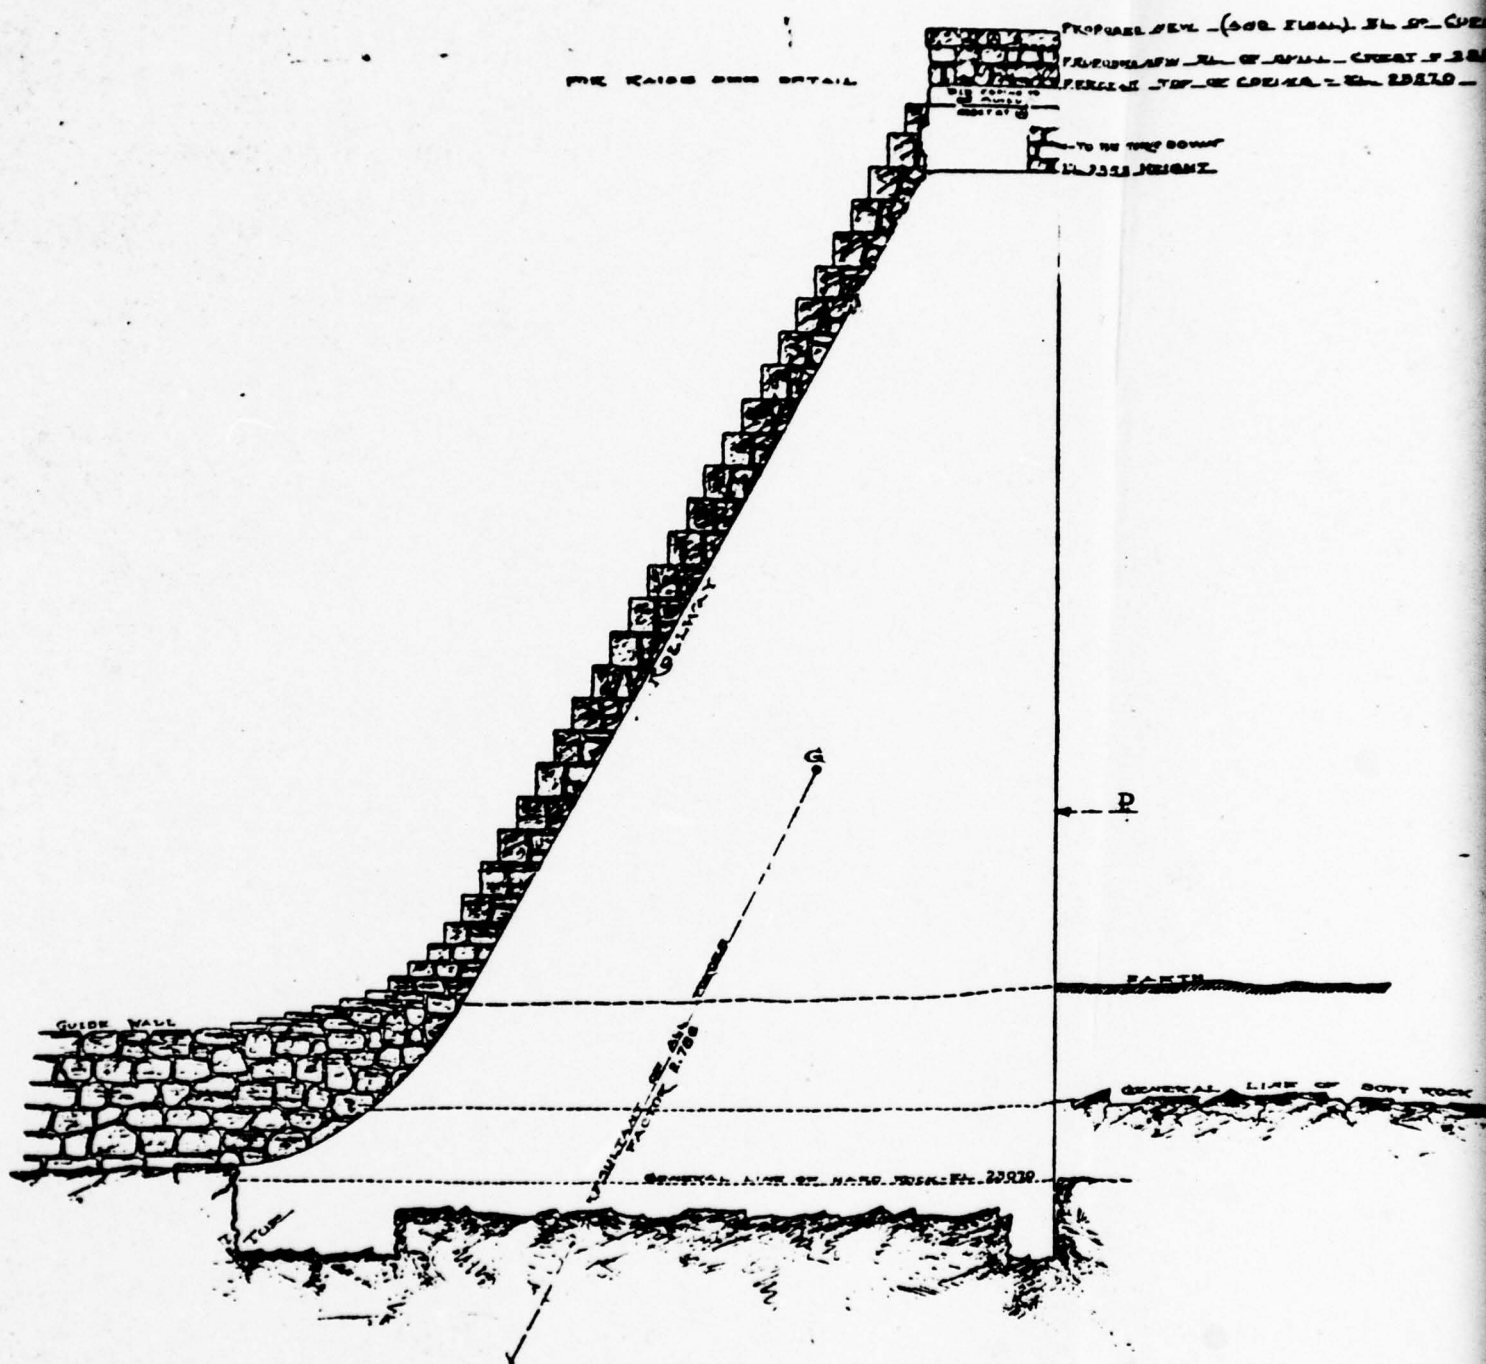
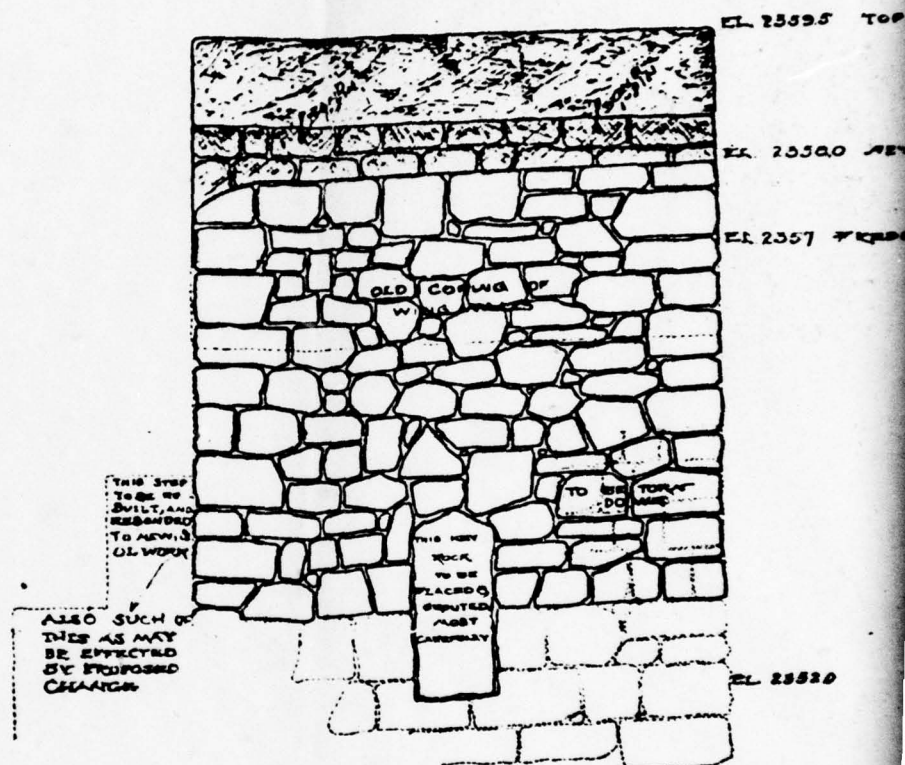
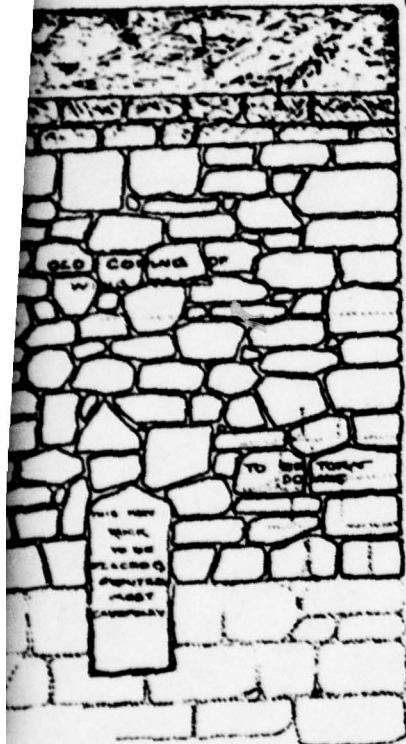
PLATE N°3

Plates 2 and 3, Appendix I shows the overburden soils and "soft rock" excavated and the structure resting on "hard rock". Key trenches are provided along the heel and toe of the dam. This method of founding the structure would provide for a good foundation. The drawings do not give any indication of design in the abutment area. Based upon the outcrops exposed

6.2.1 Foundation and Abutments: The entire dam rests 1 to 2 ft below the designated "line of hard rock" at elevation 2307.0. This represents a 38^{\pm} ft wide cut from abutment to abutment, which extends into bedrock approximately 4 ft. A 7^{\pm} ft wide and 2^{\pm} ft deep trench was then excavated along the toe of the dam while a 2^{\pm} wide and 2^{\pm} deep trench was provided along the heel of the dam. Based upon the outcrops exposed in the surrounding area and the foundation design, excessive settlement of the dam does not appear to be a problem since outcrops in the immediate area consist of fairly competent, slightly to moderately weathered bedrock. Measured attitudes indicate there are probably no adversely oriented weak planes within the foundation rock that would act as a potential sliding plane. The heel and toe key trenches increase the sliding resistance of the structure and also serve as cutoffs for any potential seepage through the foundation rock. Only minor seepage would be expected through bedrock joints.

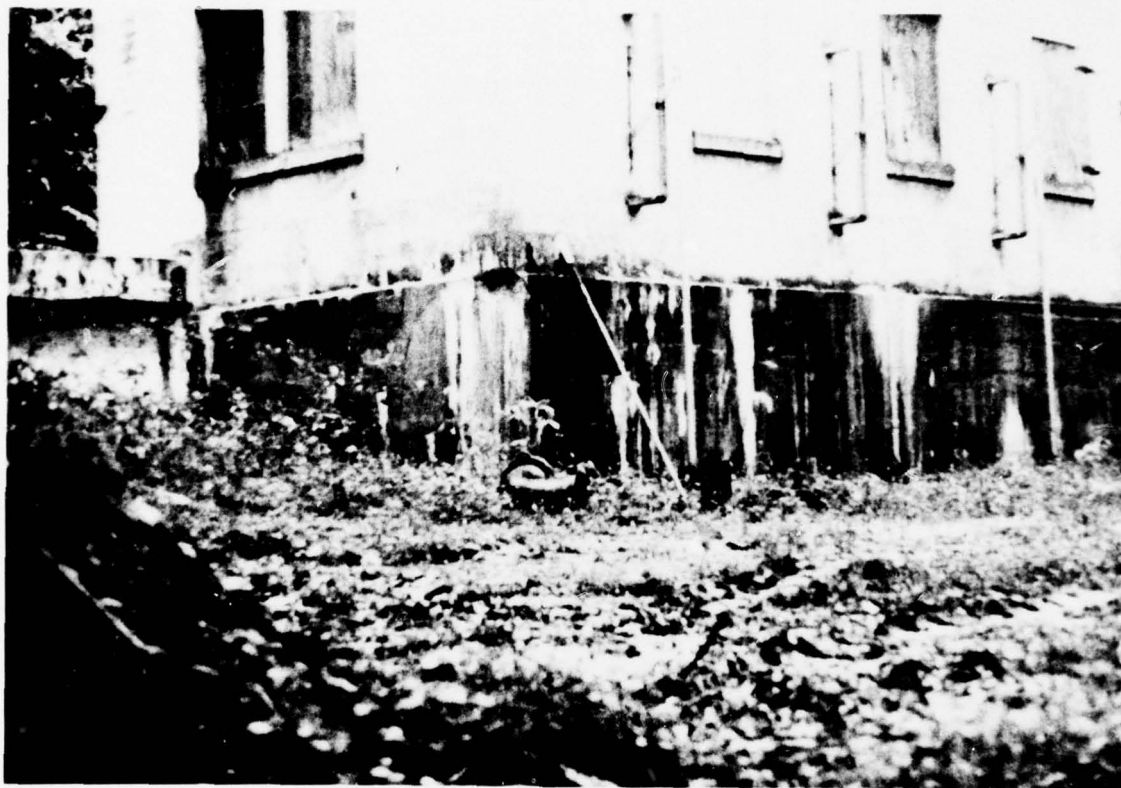
1.2.4 Hazard Classification: The dam is located in a rural area; however, based upon the downstream proximity of the Town of Appalachia and its water filtration plant (Photo No. 1, Appendix II), the dam is assigned a "significant" hazard classification. The hazard classification used to categorize a dam is a function of location only and has nothing to do with its stability or probability of failure.

PHOTO TAKEN FROM CREEK BED OF THE BACK OF WATER TREATMENT PLANT
(EYE LEVEL SIGHT IS 5'4" ABOVE CREEK BED)

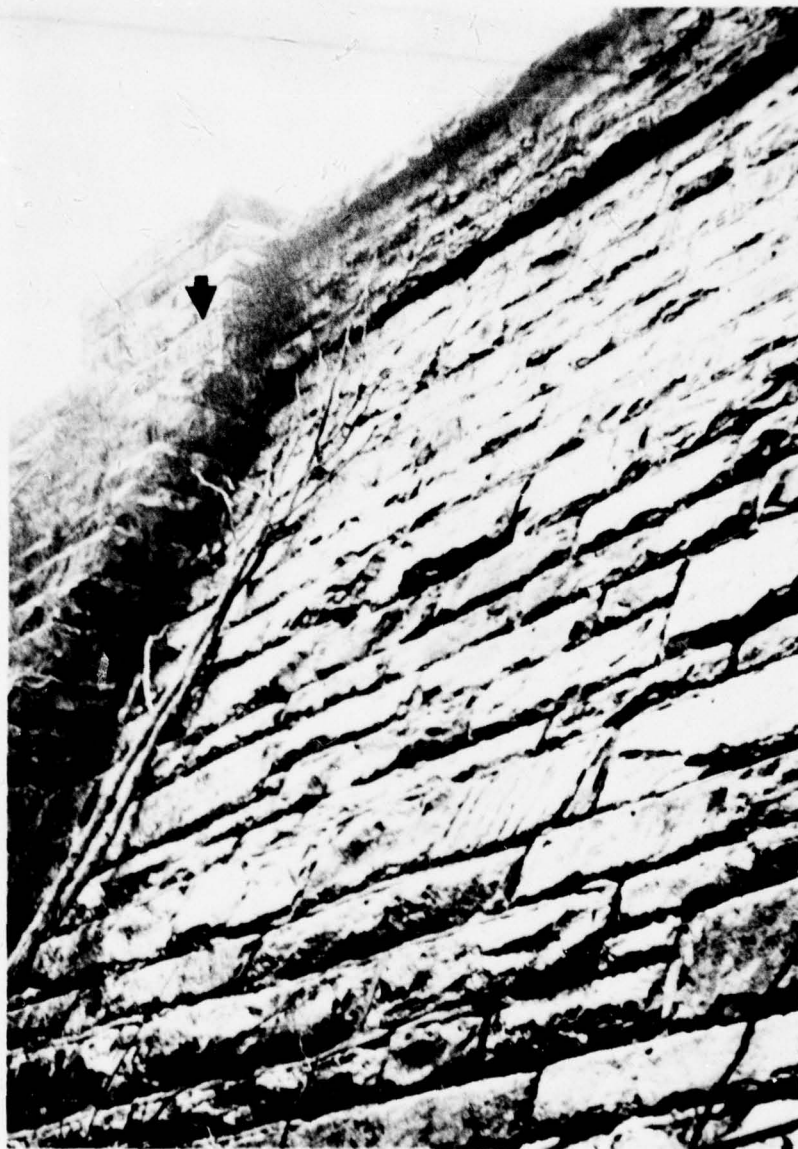
VIEW SHOWING GOOD CONDITION OF RUBBLE FACE
(NOTE DATE BLOCK - ARROW)

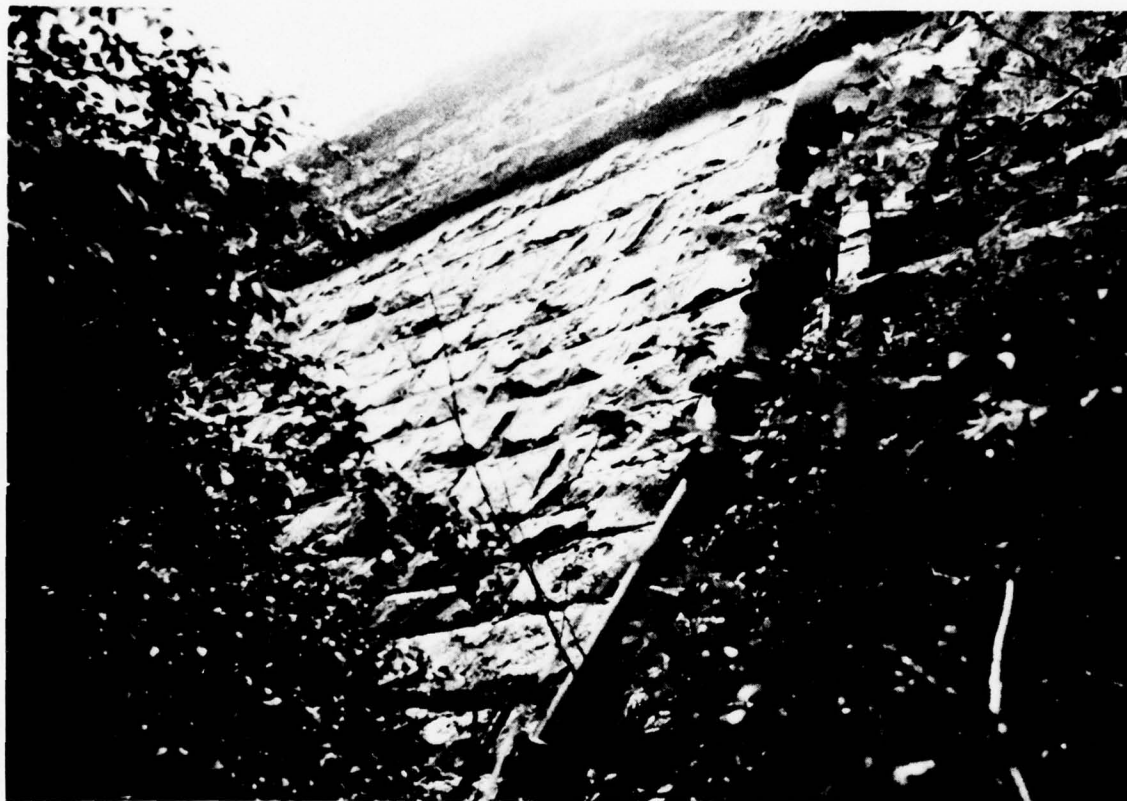
PHOTO OF FACE AND WATER INTAKE TO WATER TREATMENT PLANT

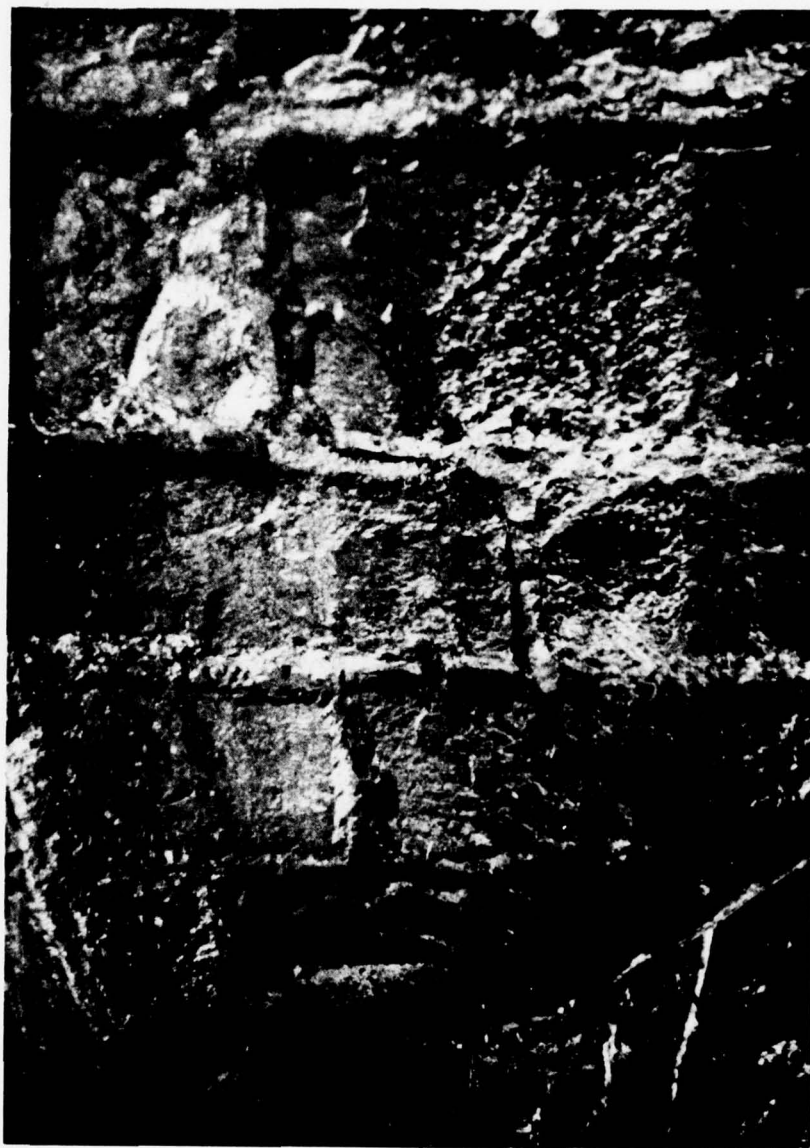
II-5

The crack in the mortar joint on the dam face did not appear to affect structural integrity of the dam but should be monitored for growth or seepage.

A surface crack was also noted in the dam about 4.5 ft from the top of the face toward the right abutment. This appears to be only surficial and is not believed to be detrimental to the structural integrity of the dam.

CLOSE-UP OF CRACK

1.6 Surface Cracks: The structure was reportedly grouted in 1936[±]. Between the fifth and sixth piers from the right abutment, a discontinuous crack was observed along a mortar joint, which also crosses a sandstone block. Entire length is 6 ft[±]. A 7 inch void in mortar was visible along the right side of the first pier, approximately 4 ft below the crest. Most cracks occur in the top 4.5 ft. Distinct crack located 4.5 ft from top near the right abutment, below coping.
